NASA
Technical Memorandum 105830

Evaluation of an Oil-Debris Monitoring Device for Use in Helicopter Transmissions

August 1992

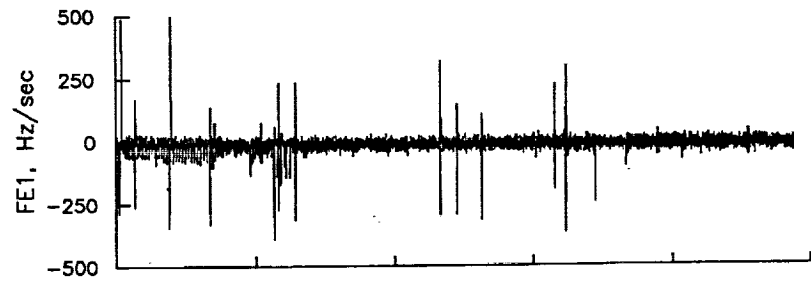
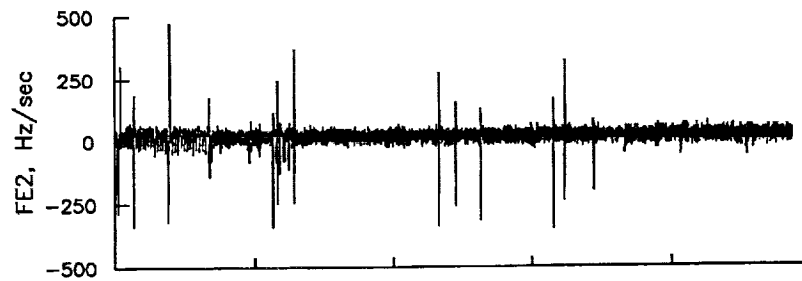
(a) FE1 parameter.

(b) FE2 parameter.

(c) Spectroscopy results.

Figure 7. — Test 2 results; no component failure after 122 hours.

Test 2 was a 122-hr endurance run with the goal of producing spiral bevel scoring and mast-shaft ball bearing micropitting failures. The operating conditions were the same as for test 1, but with reduced oil flow to the spiral bevel mesh. This test did not produce any component failures. The ODMD and spectroscopy results again indicated low ferrous content in the oil (fig. 7). The spectroscopy results indicated that the oil contained some debris at the start of the tests and then gradually cleaned itself during the run. This is not uncommon, because debris might have been left in the passageways from the previous run or might have been introduced in the transmission during build-up. The ODMD results generally agreed with the spectroscopy results showing some activity at the start of the run and then remaining constant for the rest of the test.

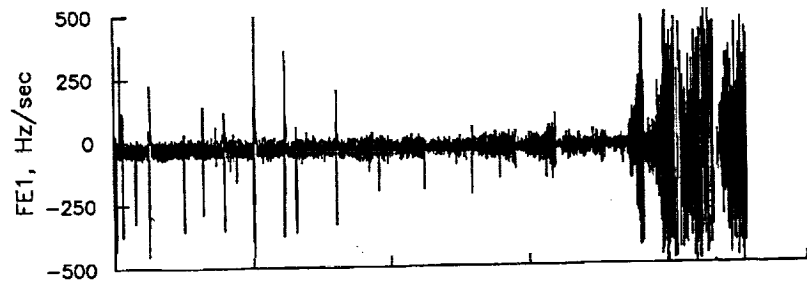
(a) FE1 parameter.

(b) FE2 parameter.

(c) Spectroscopy results.

Figure 10. — Test 4 results; no component failure after 114 hours.

Test 4 was a 114-hour endurance run with the goal of producing planetary fatigue, spiral bevel scoring, and mast-shaft ball bearing micropitting failures. A lubricant conforming to DOD-L-85734 specifications was used (this is basically a MIL-L-23699 specification oil with additives for improved load-carrying capacity). A new ODMD sensing unit was installed. As with test 2, no component failures were produced. The spectroscopy indicated an initial containment of debris, a quick cleaning of the oil, then a gradual increase of debris as the test progressed (fig. 10). The ODMD indicated activity at the end of the test, which supported the spectroscopy results. However, no significant component wear was apparent during inspection of the transmission after the test.

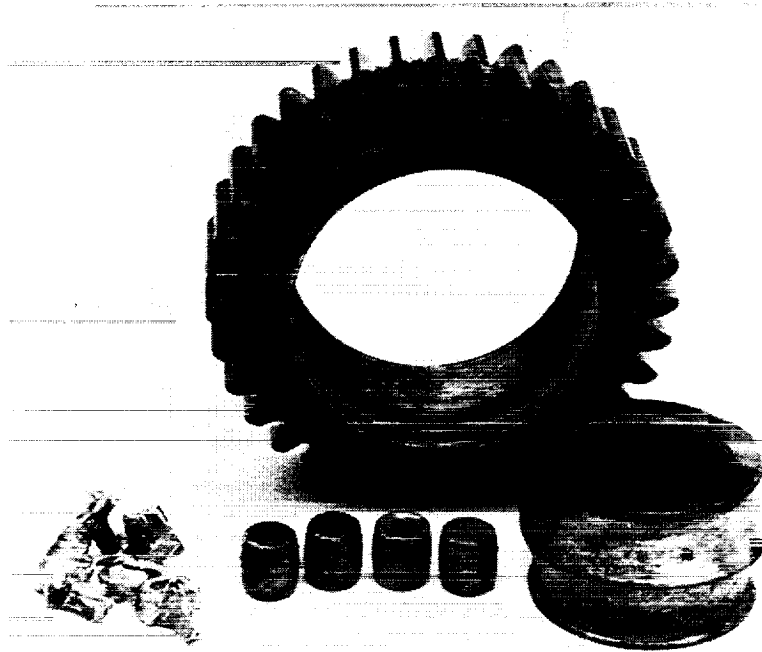
Figure 11. — Planet bearing cage failure after test 5.

Test 5 was a repeat of test 3 with the goal of producing planetary fatigue, spiral bevel scoring, and mast-shaft ball bearing micropitting failures by using the second brand of oil conforming to MIL-L-23699 specifications. At 91 hr, a drastic increase in transmission heat generation was noticed from oil and component temperatures. At this point, the test was stopped. Overhaul of the transmission revealed that a planet bearing cage was completely destroyed (fig. 11). Unfortunately, the ODMD sensor failed and gave erroneous results after about 20 hr (fig. 12). This was the second failed sensor. No spectroscopy was performed, because the ODMD sensor failed during the initial part of the test. It is possible that the prolonged exposure to the relatively high oil temperature of 121 °C (250 °F) contributed to the sensor failures.
